The Vermiculation of Washington DC

Sean
Lynch

This booklet, freely distributed and accompanied by a series of photographs exhibited at the Transformer gallery in June 2012, details the exterior of the Renwick Gallery on Lafayette Square. A focus is placed on the pilasters or columns on the first floor where the stonemason's skill of vermiculation is evident. Here, one can see irregular holes carved into sandstone, intended to represent worms eating their way through the stone, collapsing it into rubble and ruin.

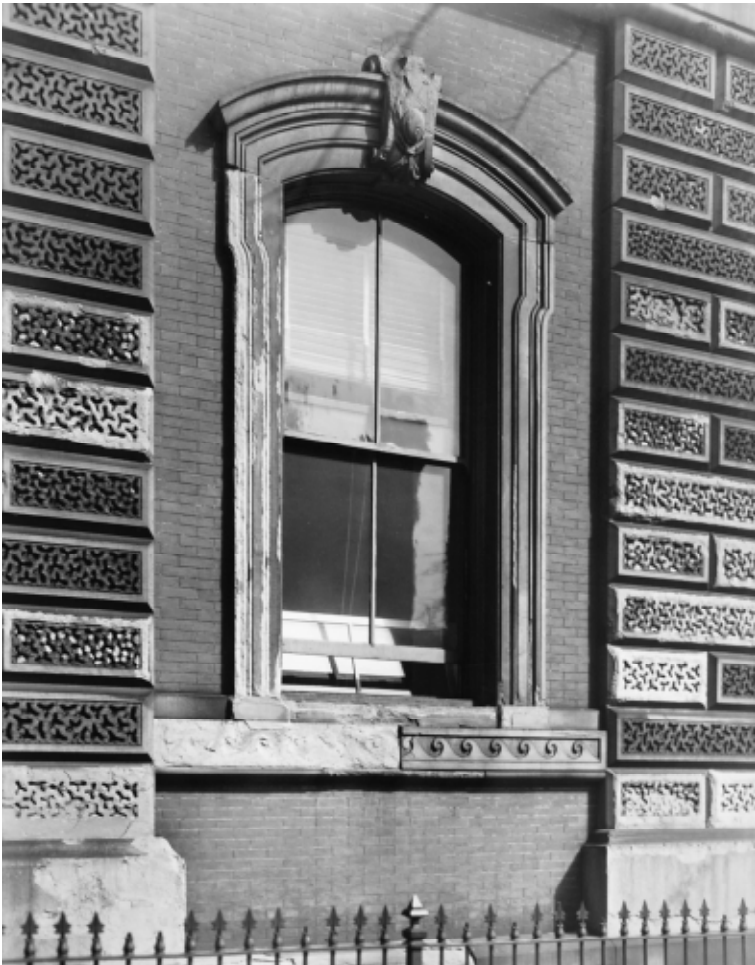
Photograph detailing crumbling sandstone, ca 1920-59 by Theodor Horydczak

Air pollution, bird droppings and water penetration into the porous Seneca Brownstone were all discussed as reasons for a deterioration of the building's sandstone ornamental and vermiculated trimmings. By 1947, an unrealized renovation using limestone was mooted:

"A request is made for the sum of \$177,200 to resurface the brick and sandstone trim exterior of the building, the sandstone portion of which is gradually eroding away. Not only has the sandstone surface eroded to the extent that all character of the original design has nearly disappeared, but large pieces of stone continue to fall, endangering the lives of passing pedestrians. The estimate covers the cutting back to the brick face of projecting sandstone trim, etc., and the facing of the entire exterior with a limestone veneer thoroughly bonded into the existing walls.

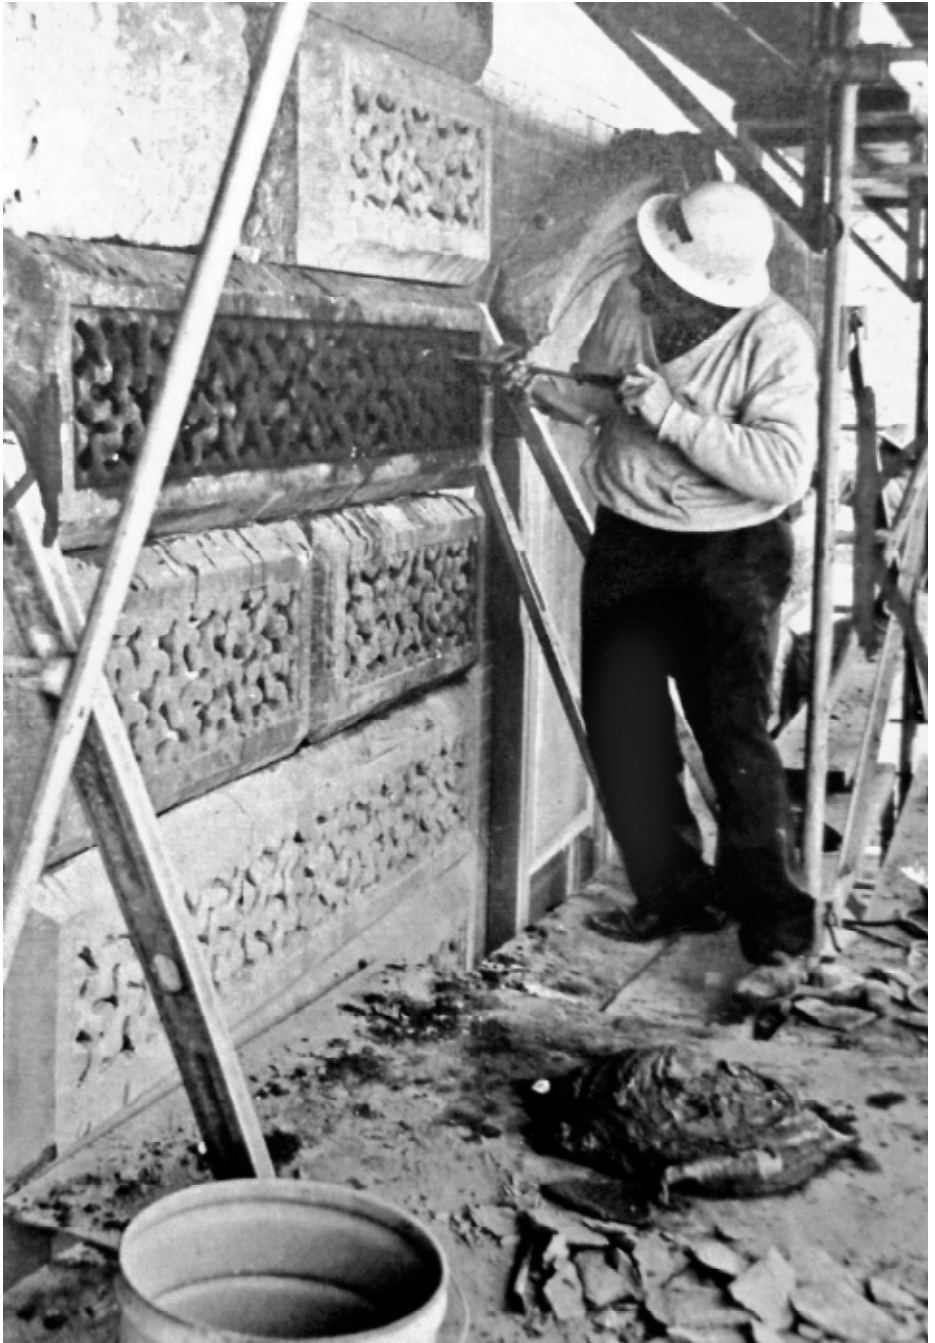
Restoration work on the Renwick Gallery, early 1970s

President Lyndon B. Johnson decides to save the building from destruction, and hands it over to the Smithsonian. Universal Restoration Inc. is subcontracted to repair the building's façade between 1967 and 1972. Using photographs taken by Matthew Brady in the 1860s, careful study was made of the compositional forms of its' ornament, much of which now decayed. They remove all sandstone, crush it up and mix it with a new synthetic building compound called Permo-bond. Using this material, the ornament on the façade is recast, placed back in situ and finished with a layer of another synthetic material called Dekoist, "an example of a new direction on historic restoration and preservation, an Amalgam of art and technology fused together by the fire of imagination and the unremitting dedication to the attainment of uncommon standards of excellence."
